RSA Background

The Brooke Hancock Jefferson Metropolitan Planning Commission (BHJ MPC) along with the Cross Creek Police Department, Township Board of Trustees, and Ohio Department of Transportation conducted a Road Safety Audit (RSA) for Cadiz Road between Springdale Ave to Two Ridge Road from August 27th to August 28th. BHJ MPC selected this urban non-freeway segment based on crash vulnerable locations identified in the Jefferson County Local Road Safety Plan. Although the local safety plan ranked this location as 18th highest vehicle crash location between calendar years 2013 through 2018, this segment experienced the highest number of non-motorized fatalities and serious-injuries.

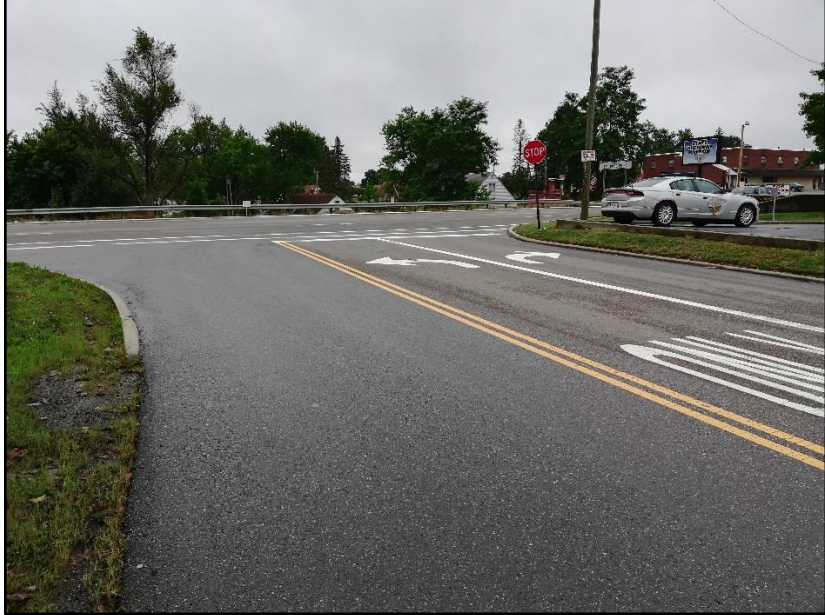
Features	Pictures
<p>1. Stop-controlled Intersection at Two Ridge and Cadiz roads. Area of concern for multiple left turn crashes turning from Two Ridge to Cadiz Road.</p>

The Two Ridge and Cadiz Road intersection is stop-controlled. The left turn movement from Two Ridge road to Cadiz road is a major safety concern for this road. As traffic is taking a left turn from Two Ridge, must cross 3 lanes (two thru and one turning) with west bound traffic approaching at average over 45 MPH. Drivers are unable to properly yield to oncoming traffic which may be cause for many of the left turn related crashes. Inadequate night lighting may also contribute.

Time Period	Recommendation	Example	Anticipated Cost
Short (<1 Year)	Reduce Speed Limit.	Perform Engineering Study to determine proper speed limit for known conditions and step up law enforcement to reduce speeding. See Appendix A for preliminary findings.	\$
	Clear intersection obstructions		\$
	Consider constructing center median turn lane at intersections.

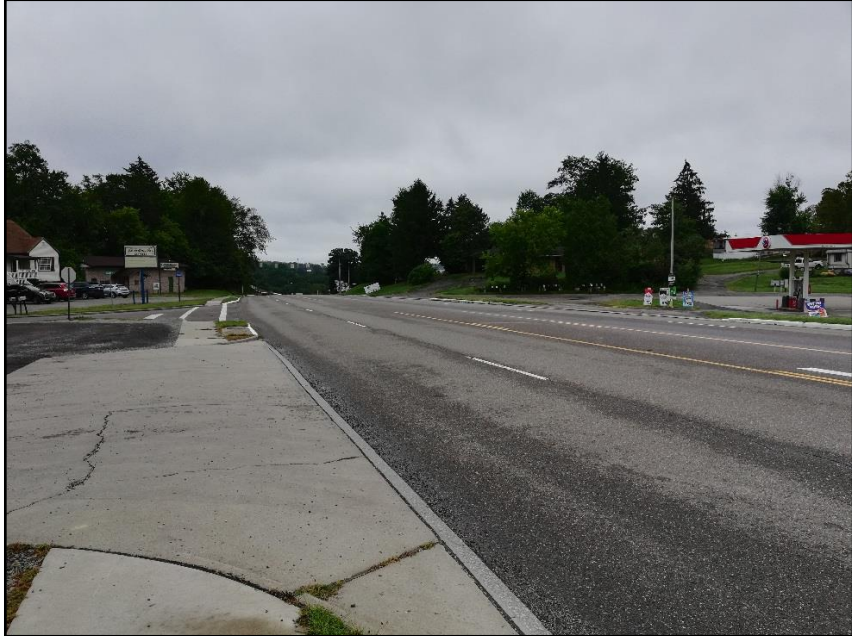
<p>2. No marked Crosswalk. All the pedestrian crashes took place at this Malone Ave-Cadiz Rd intersection.</p>

From 2013-18 this segment of road observed 3 pedestrian incidents where one person died and two were found seriously injured. Since there is no crosswalk in this whole road segment and there are retails, food and convenient stores and residential development on both sides of the roads, this is an urgent necessity. Due to the speed and lack of lighting at night time, it is a very hazardous location for pedestrian crossing. Moreover, these businesses are situated in a position where the vehicles are already at a high speed due to uphill grade, and the risk of severe crash goes higher.

Time Period	Recommendation	Example	Anticipated Cost
Short (<1 Year)	Construct Mid-Block offset pedestrian crossings with pedestrian refuge at selected locations

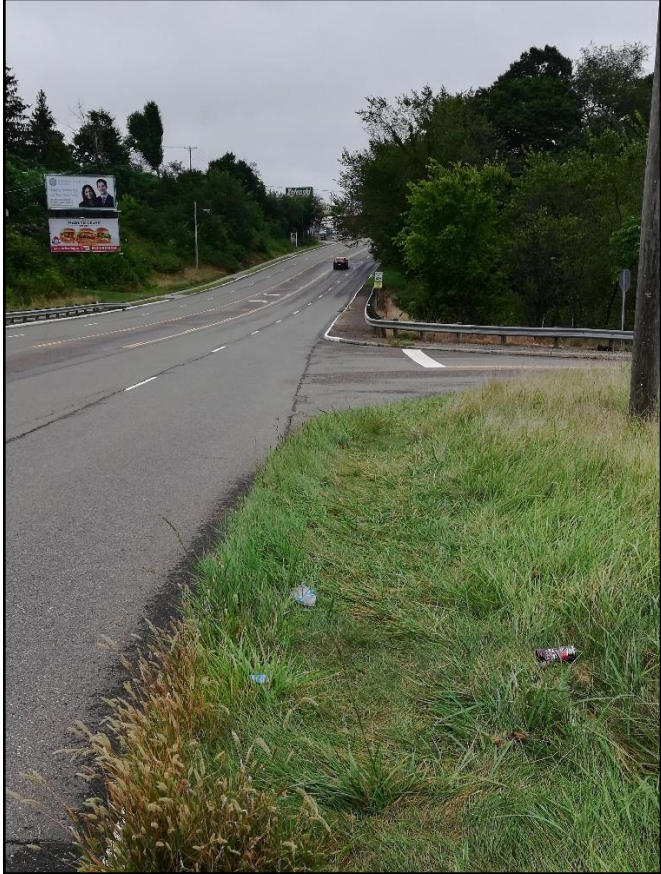
Features	Pictures
<p>3. Limited sight distance due to horizontal and vertical curves.</p>

The current speed limit on this road is 45 MPH, but just before this segment, the speed limit is 35 MPH, which has the same roadway configuration as this study area. This stretch of road has multiple side streets and driveways that access residential and retail stores. Line of sight distance is restricted due to vegetation and business signing along with vertical and horizontal road alignment.

Time Period	Recommendation	Example	Anticipated Cost
Short (<1 Year)	Review speed limit.	Perform Engineering Study to determine proper speed limit for known conditions and step up law enforcement to reduce speeding. See Appendix A for preliminary findings.	\$
Medium (2-3 years)	Install Rumble Strips specially before pedestrian crossings and blind curve locations.

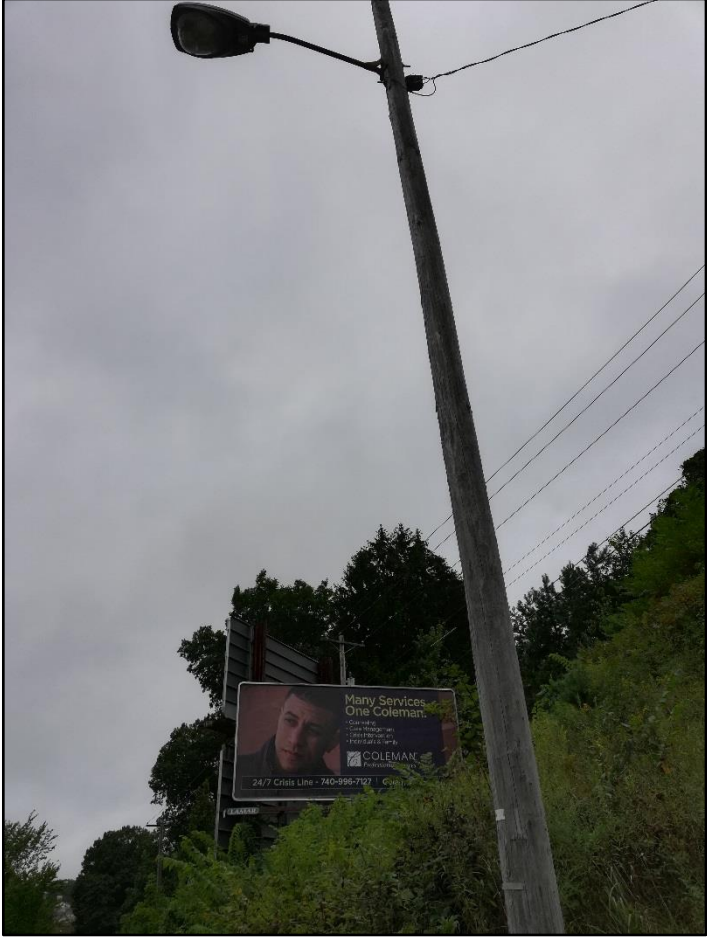
Features	Pictures
4. Antiquated Lighting System

Roadway lighting condition along the corridor is poor. The existing lighting system is outdated.

Time Period	Recommendation	Example	Anticipated Cost
Short (<1 Year)	Low cost lighting system installation

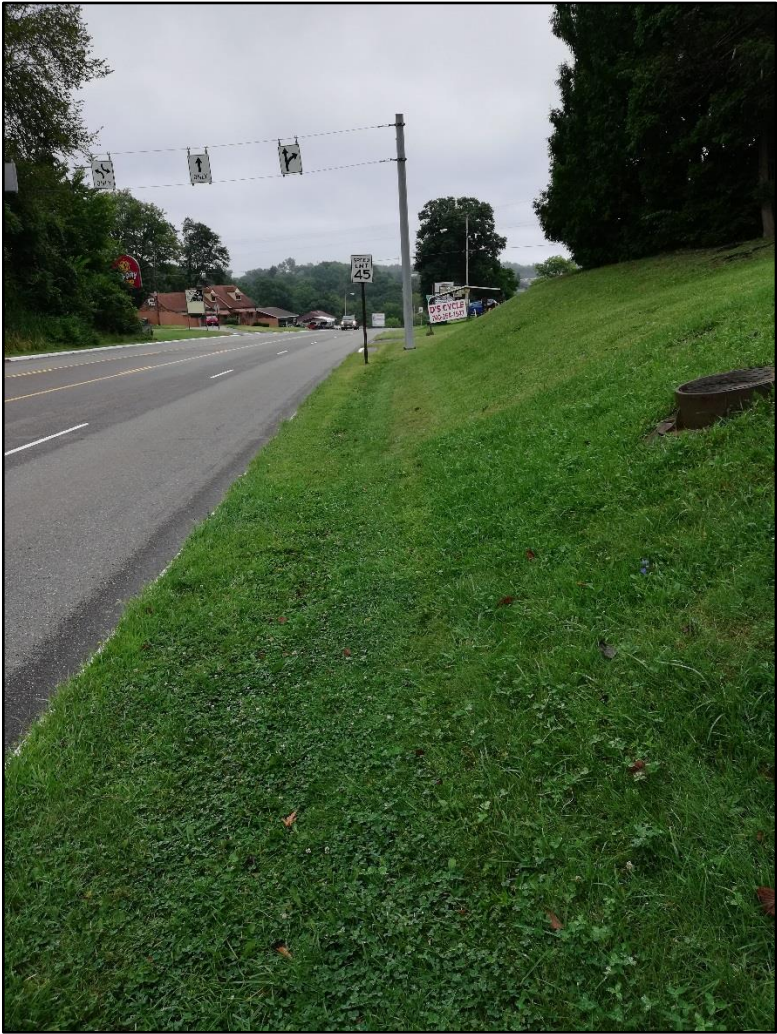
Features	Pictures
<p>6. No Sidewalk on East bound side of the road. Evidence of pedestrian traffic walking over the grass.</p>

Time Period	Recommendation	Example	Anticipated Cost
Long (4-5 Years)	Sidewalk on East Bound

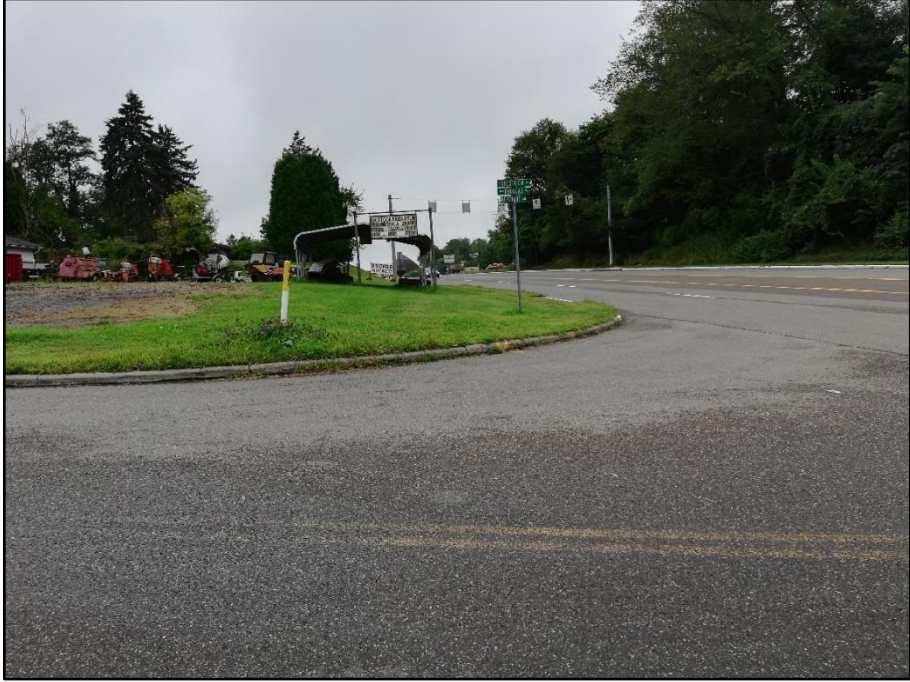
Features	Pictures
<p>7. Poor sight distance due to signs, structures and, vegetation.</p>

Time Period	Recommendation	Example	Anticipated Cost
Long (4-5 Years)	Evaluate stop sign placement at entrance roads and remove sight distance obstructions.

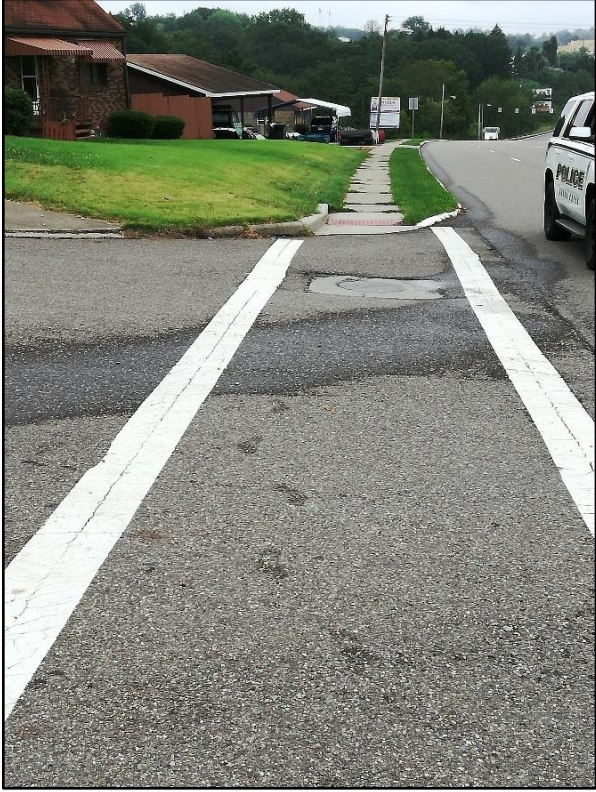
Features	Pictures
9. Obstruction in crosswalk.

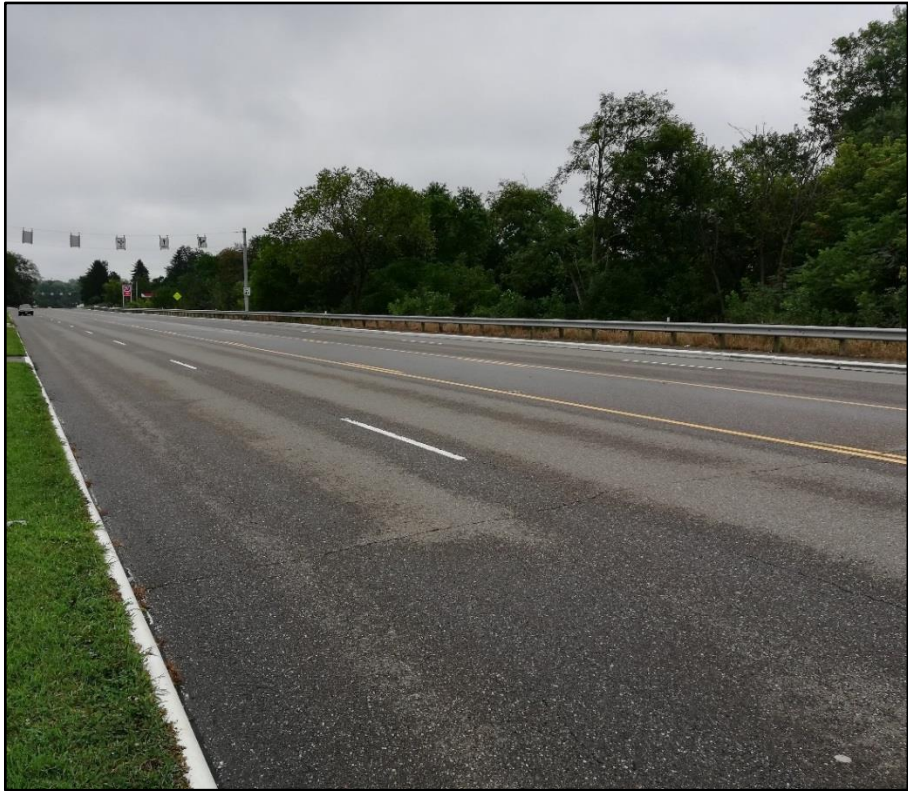
Features	Pictures
10. Median turn lane with no access driveways.
